Devil's Slide/Hwy 1 Storm Repair

Daily Updates from Bijan Sartipi

Daily Update
May 30

Devil's Slide (post mile 39.14)

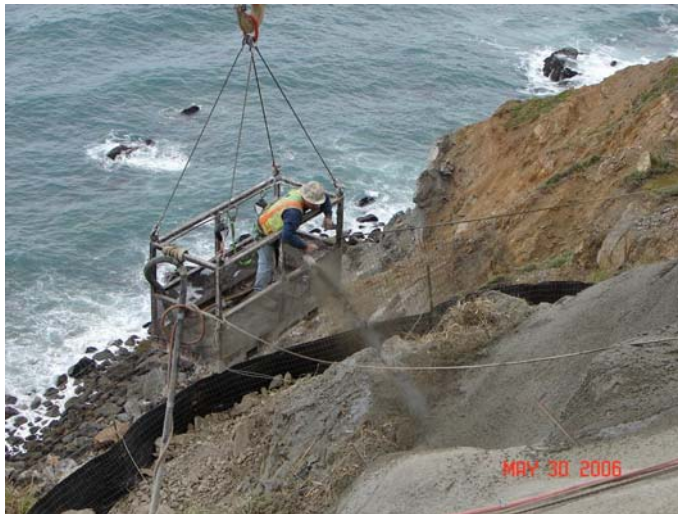
Applying shotcrete over part of the rock dowel area.

- Rock dowel drilling and installation continued to-day. Approximately 90% of the rock dowels are now installed. After dowels are installed and grouted in position, shotcrete is applied over exposed areas and into cracks resulting from slide movement. The original layer of shotcrete was applied as part of the 1995 repair to consolidate the fractured surface.

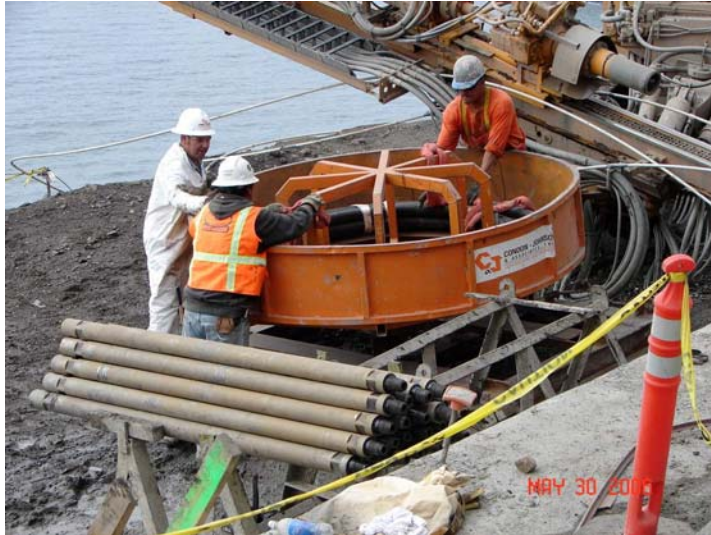
Loading the tie back cable assembly onto the dispensing reel prior to manually pushing it into the 150 feet deep bore.

- Drilling for the 150 feet long tie backs continued. After drilling to the required depth the tie back cable assembly is manually pushed into the six inch diameter bore and then grouted in position.
